Fretting damage parameters in splined couplings

V. Cuffaro, F. Curà, A. Mura

Department of Mechanical and Aerospace Engineering, Politecnico di Torino, Torino (Italy)

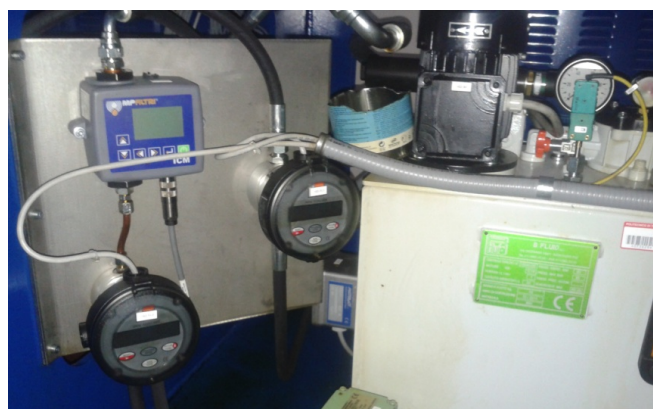
Figure 1: Inline contamination monitor connected to the lubrication system of the splined couplings test rig.

In order to monitor these particles a special instrument called ICM (In-line Contamination Monitor) of the MP-filters has been installed; thanks to this it is possible to determine the number and the size (from 4 at 25 microns) of the debris particles present into the oil

During the tests it is possible to monitor a lot of experimental data (debris present in the oil, temperature and strain of the specimen, speed rotation, torque, etc.), in particular the debris monitoring has been done by means of the inline contamination monitor (ICM) that measures and quantifies the numbers of solid contaminants in hydraulic, lubrication and transmission applications [13]. The instrument uses a light extinction principle whereby a specially collimated precision LED light source shines through the fluid and lands on a photodiode. When a particle passes through the beam it reduces the amount of light received by the diode, and from this change in condition, the size of the particle can be deduced.

The ICM is designed to be an accurate instrument for permanently installed applications utilizing mineral oil as the operating fluid. The unit can operate using any of the international standard formats ISO 4406:1999, NAS 1638, AS 4059E and ISO 11218 [12].

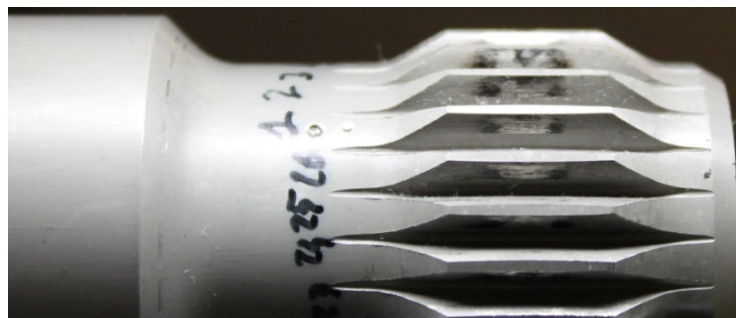
Figure 3: Specimen MB3 after test.

Fig. 1, 2 and 3 show teeth after wear test of respectively specimen MB1, specimen MB2 and specimen MB3

It is possible to point out that after test MB1 (performed without misalignment) the teeth surface doesn't show any evident trace of wear damage. Considering tests MB2 and MB3 it is possible to observe that the wear damage appear on teeth surface and the damage in test MB3 is bigger than in test MB2, that is reasonable because test MB3 has been performed with higher misalignment angle (10°) respect to test MB2 (5°).
